QA-148
Blue Lantern Inn
Centreville
Private

INVENTORY FORM FOR STATE HISTORIC SITES SURVEY

Blue Lantern Inn

110-112 South Commerce Street

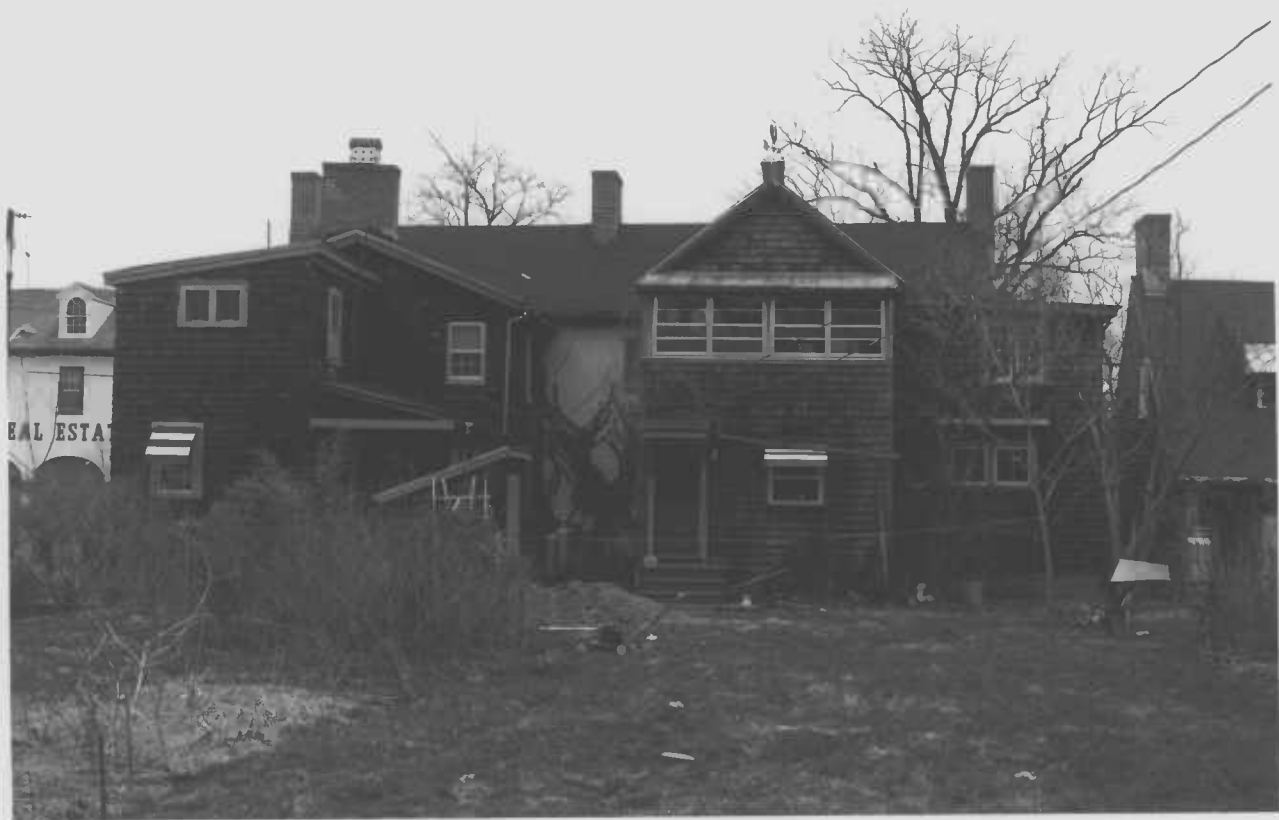
QA-148

Blue Lantern Inn
South Commerce Street
Centreville, Maryland
Orlando Ridout V 1980
Rear facade from West
